# The Aguadilla airport case (04/25/2013)

The report below exposes the in-depth study of a case of UAP observed at the Rafael Hernandez Airport site in Aguadilla, Puerto Rico, on April 25, 2013 at 9:20 p.m. (local time) based on the analysis of testimonies, the recording video and radar data.

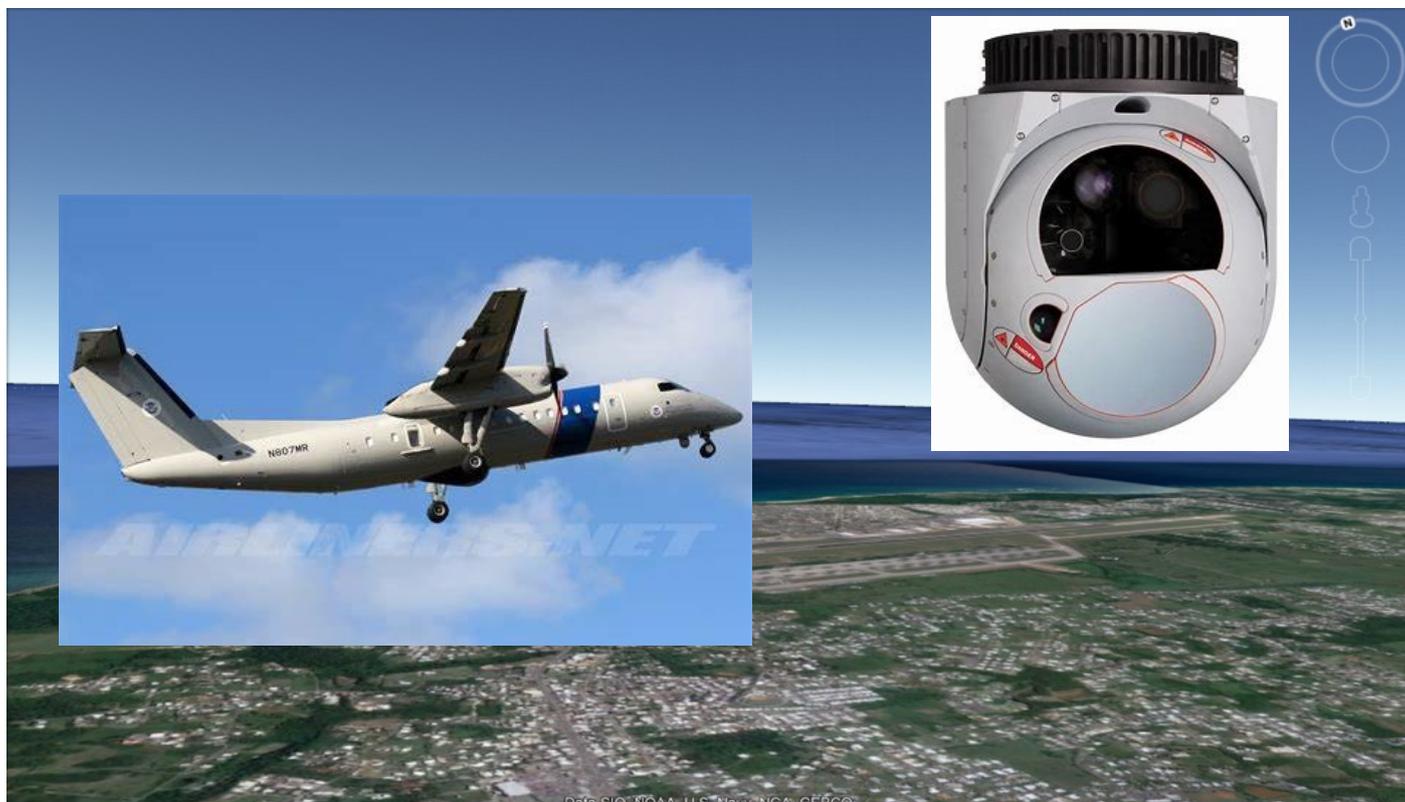
**Figure 1**

**The video images** have been recorded from the WESCAM MX-15D airborne imaging turret video output. The WESCAM MX-15D is mounted under the nose of an American DHC-8 customs and border protection (CBP). The system's infrared sensor operates in the MWIR mid-infrared band between 3 and 5 microns.

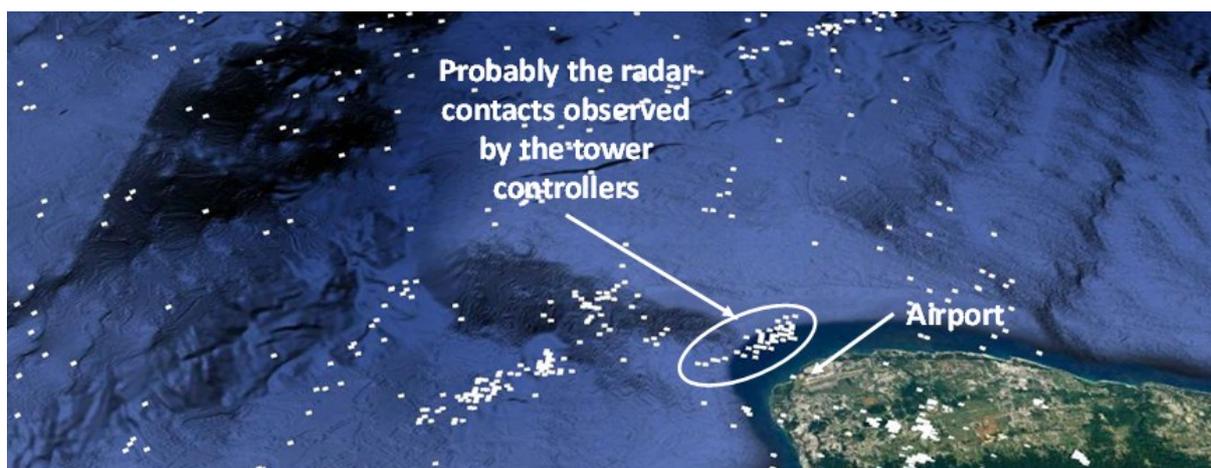
**Fig. 3 - Primary radar contacts from 20:58 to 21:26 LT (white dots)**

The plots move from the North-East to the South-West at a speed of 30 to 40 kilometers per hour ; their estimated altitude is between 200 and 600 meters. The meteorological data (significant cloudiness in April, 74% of the time, rain probability 30% of the time, between 30 and 70mm, wind direction mainly East and North-East) may cause moving stormy phenomena, driven by the prevailing winds over the sea; these phenomena are likely to cause radar echoes.

The alert likely comes from the plots grouped in swarms (circled in Figure 3) to the northwest and west of the airport. Analysis of the radar data show that, in this swarm and in the one extending it to the west, only one plot can be seen per antenna turn, every 12 seconds.

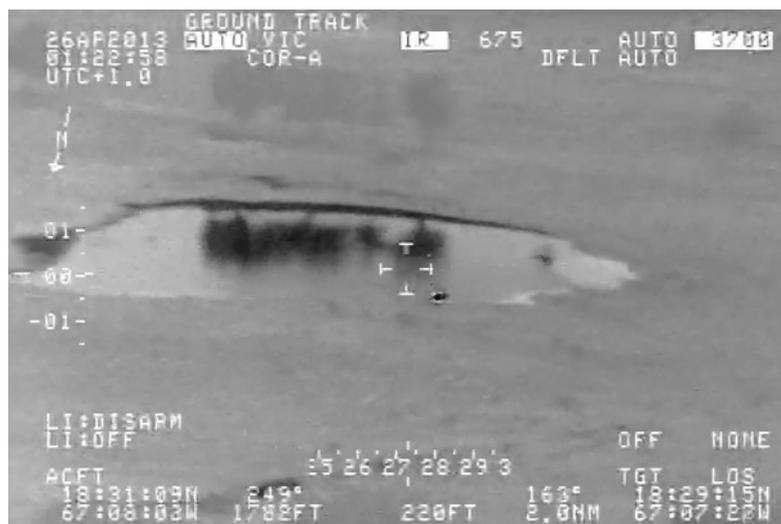
Fig. 5 – Contrast inversion

The shadow of the trees seemed more intense than the trees themselves. In fact, we are in reverse contrast; the pond reflects the sky which is cold, but the trees screen the sky, hence a strong contrast.

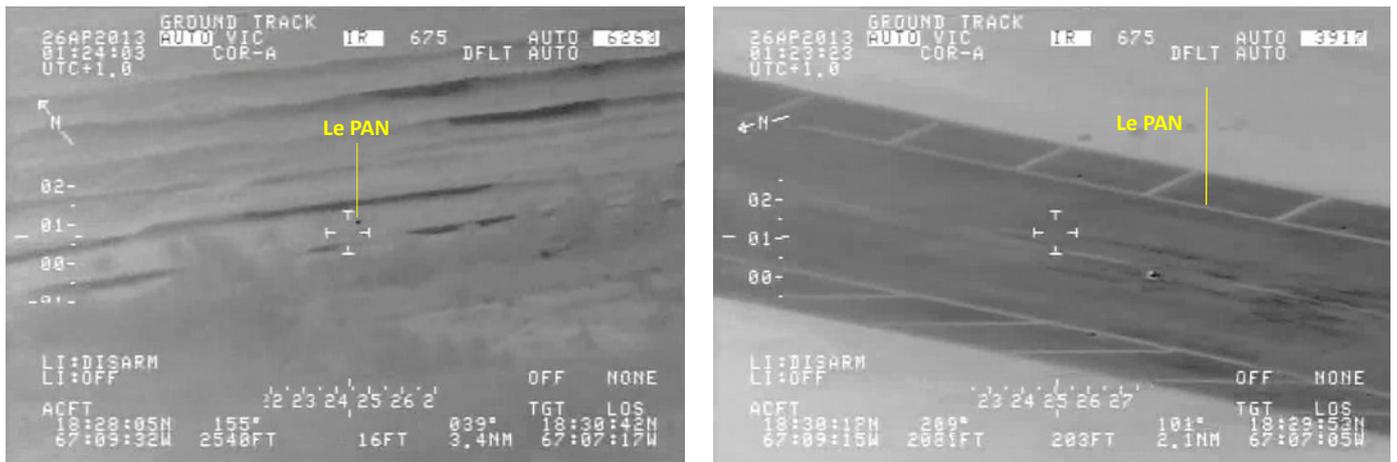
**Fig. 7 – On the left view, the target distance is 6300 m, the calculated size is 1.2 m – For 3900 m (right view), the size is 1.3 m, confirmed by comparison with the width (45 m) of the central strip of the runway – the maximum size is that of an object close to the target i.e. close to the ground.**

It can be evaluated from the angular field data available in the technical manual of the Wescam MX-15Di, which allows to know the opening of the visual for a given magnification, therefore to measure the angular size of the UAP; the maximum diameter of the UAP can then be calculated by considering that it is at the same distance as the target. The presence, on the video image, of elements whose metric dimensions are known (aircraft on the ground, width of the runway) validates this approach.

The values found are: 1.1 m to 8 km, 1.2 m to 6 km, 1.3 m to 4 km.

We can thus affirm that the maximum diameter of the object is of the order of 1.2 m, but that its apparent diameter increases slightly when the object is closer to the plane, probably because of the increase of its brightness.

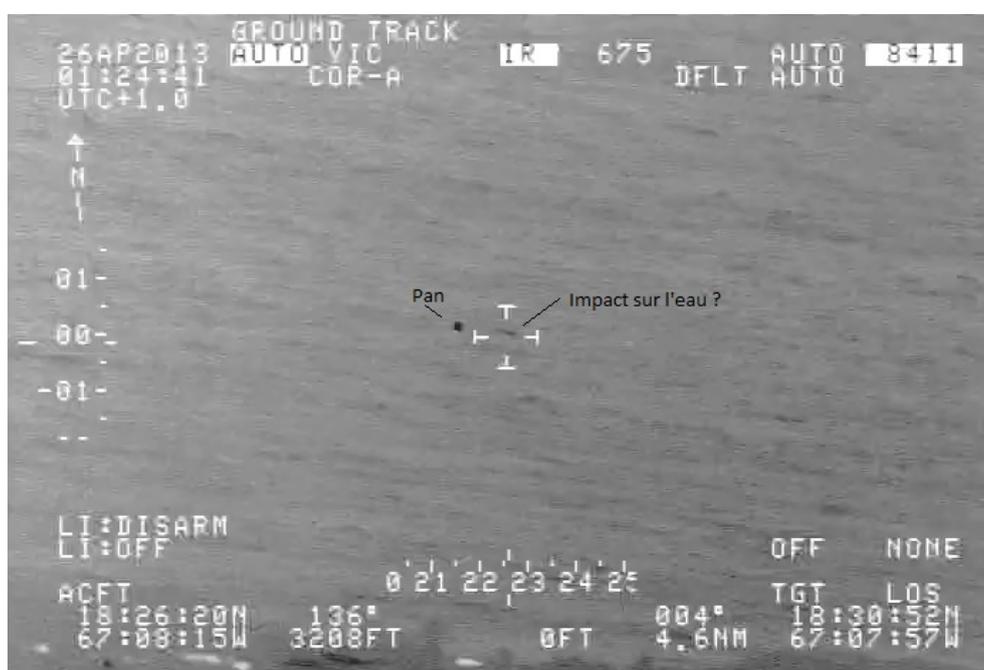
A strange "physical" phenomenon occurs when UAP appears to impact water. The explanation given in the SCU report refers to a phenomenon called Bernoulli's wavelet: the principle would be based on the effect of water displacement by the body moving underwater, which thus creates a ripple which rises towards the surface. As it rises, this wavelet expands and cools, which explains, according to the report, that the camera can follow a "cold" point in the water marking the position of the object. **However, we are in reverse contrast : a black point is a hot point and no longer a cold one!!** We do not know this effect and therefore cannot conclude, except for the fact that the water is not transparent to infrared radiation and therefore the camera cannot detect the submerged object if it is.

Fig. 9 – Impact of the UAP in the sea ?

- anomaly related to the image acquisition system with parasitic reflection (hypotheses questioned by the lack of attenuation of the reflected image),
- swarm flight of two drones in close formation, then temporary separation (physically possible scenario),
- rupture or duplication of the drone-type object upon impact on water,
- fata morgana type candling effect with refraction on cold air layers, but weather conditions and the possibility of infrared candling have not been demonstrated.

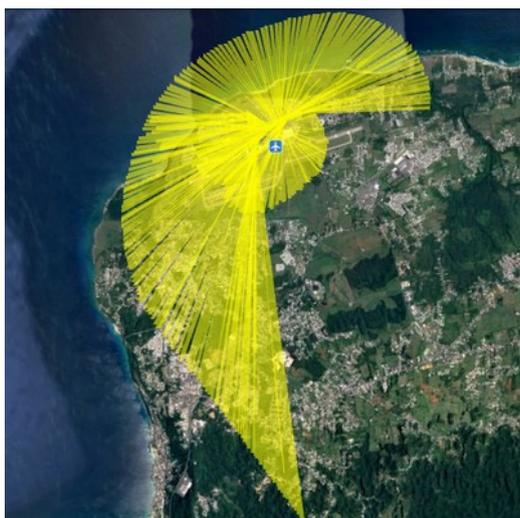
The real airplane to UAP distances cannot be defined ; it is not possible to deduce from the video the position of the UAP on the LOS, nor its speed, nor its altitude. We can only say that the projection of its trajectory is inside the yellow area swept by the lines of sight (figure 13).

Fig. 13 – The projection of the UAP trajectory is in the yellow area

**Lines of sight** : they present a very interesting characteristic regarding the development of possible UAP trajectories hypotheses ; indeed, all the lines of sight intersect in a narrow area close to the airport (see Figures 12 and 13).

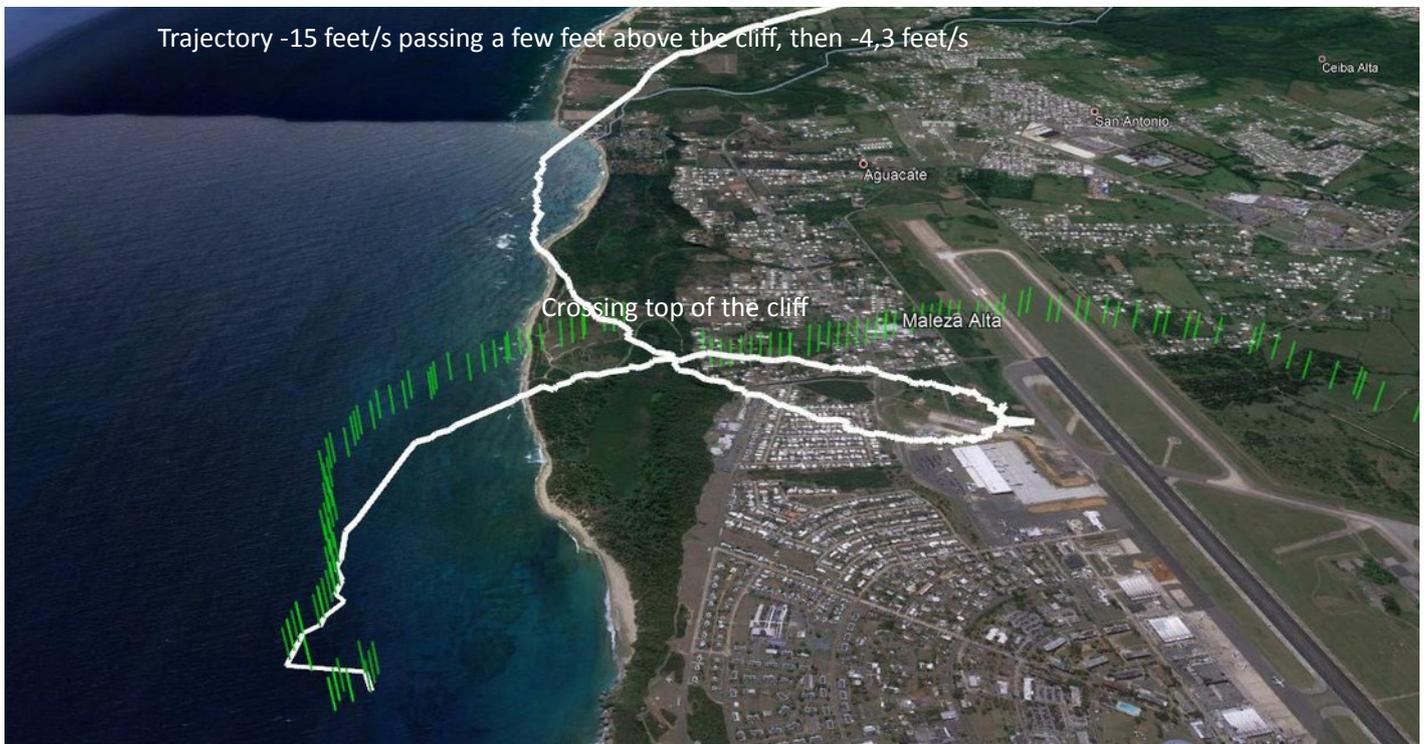
These trajectory profiles are theoretically possible. We can also imagine other flight profiles with higher vertical speed up to second 108, then decreasing when passing the cliff. The profile below is initialized from an altitude of 1800 feet with a  $VZ$  of  $-15$  feet/s.

**Fig. 25 – Trajectory with high VZ value at the beginning**

This type of profile leads to strong speed variations : 300 km/h decreasing to 50 km/h before reaching the 100/150 km/h values range at the end.

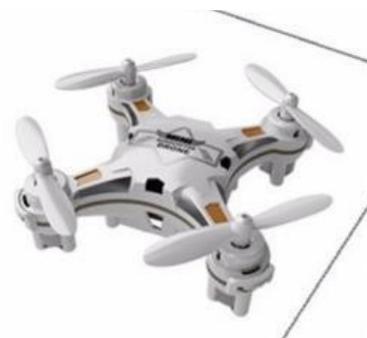
- Electric mini drones and micro drones

They are the most "discreet" of the mobiles on the list ; small size (a few tens of cm), and above all, no internal combustion. Electric engines dissipate little heat. We therefore have a very low IR signature in band 2 and band 3, with an apparent temperature of 35°C to 45°C (depending on the band and the model) giving observation ranges of the order of one to several km. They are visible in daylight and the signature strongly depends on the paint used ; is very weak at night. To refine the detectability of the various vehicles (drones, lantern, etc.) by the aircraft's IR camera, a specific linkage analysis should be carried out, which has not yet been carried out.

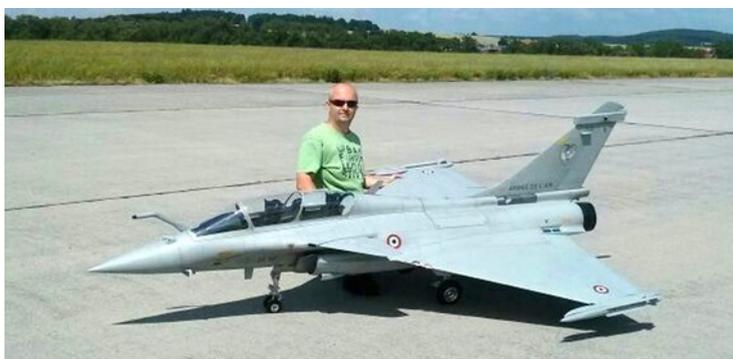
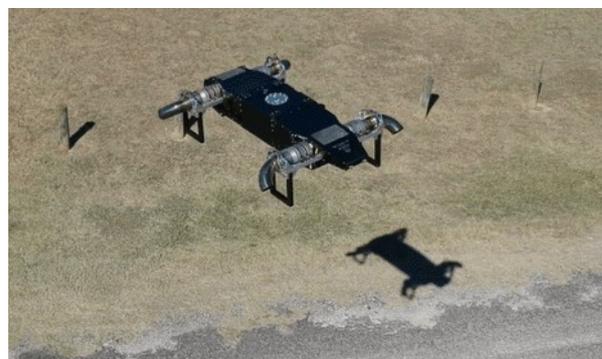
**Fig. 28 – Scale model (Rafale) and JetQuad**

The propulsion is provided by one or 2 micro reactors.

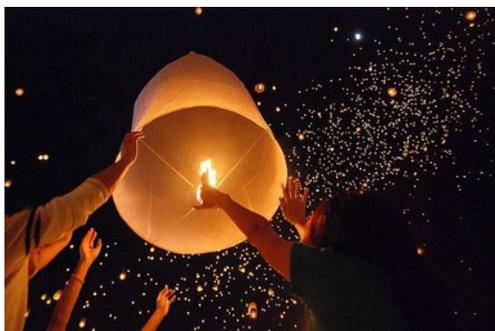
Typical size is less than 1m. We performed SIR measurements on 2 types of lanterns of comparable sizes. The measurements are taken outside, but by retaining the lantern by a wire so as not to drop it in the Paris region. The measurements are carried out with a thermal camera band 3 and a thermo point which provides a poor quality image but a very good apparent temperature measurement. Some examples of the images obtained are given below.

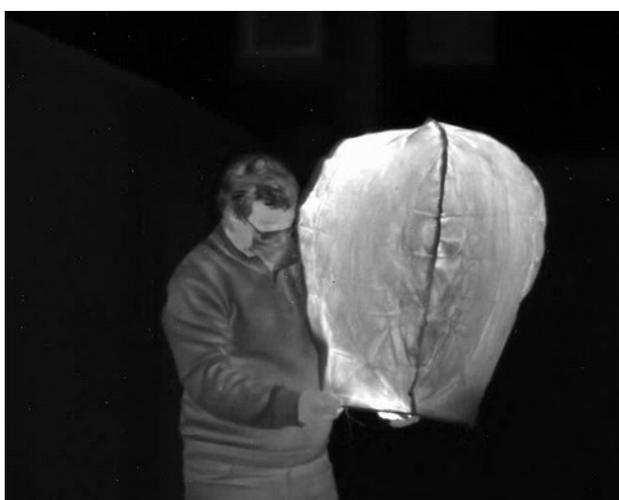
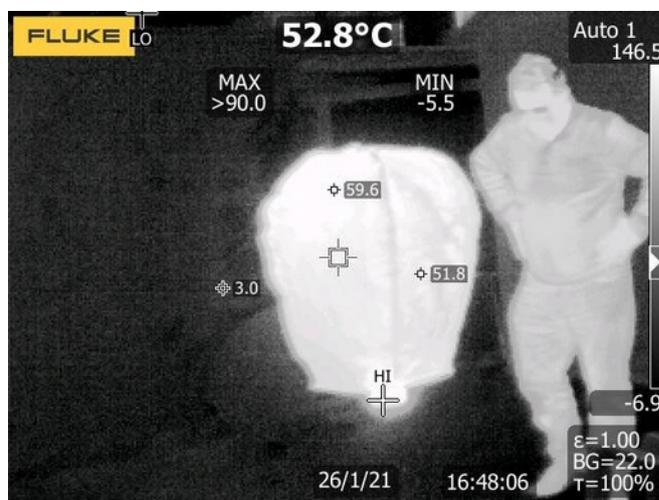
A fairly high measured temperature (between  $50^\circ\text{C}$  and  $60^\circ\text{C}$ ) is observed and confirmed by contact measurements. As the lantern is captive, these measurements correspond to a maximum. However, these values must be reached for the lantern to fly. The ambient temperature was  $4^\circ\text{C}$

**Fig. 29 – On left : example of band 3 IR image – On the right : thermo point image ; the temperature displayed at the top ( $52.8^\circ\text{C}$ ) corresponds to the center of the image, the 3 measuring points on the periphery give an idea of the dispersion**

In summary, as long as the flame is burning, the IR signature of the lantern is significant and, at night, the visible signature is important ; but, as soon as the flame is extinguished, the visible signature disappears and the infrared signature collapses very quickly.
